ON-SITE AMBULANCE CRASH INVESTIGATION

CASE NUMBER - IN10032
LOCATION - WEST VIRGINIA
VEHICLE - 2003 FORD E350 TYPE II AMBULANCE
CRASH DATE - September 2010

March 7, 2011

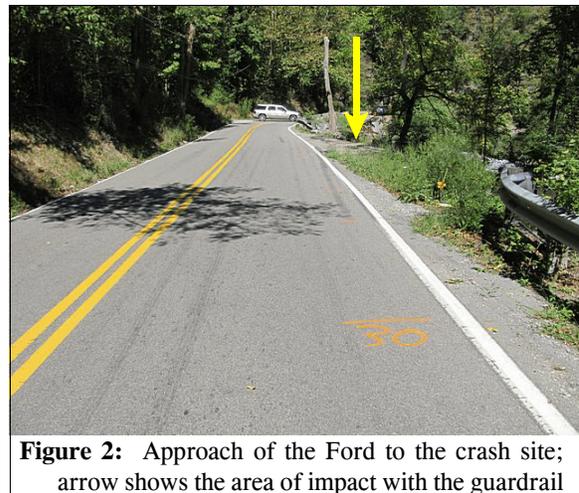
Pre-Crash: The ambulance was traveling north without the emergency lights and siren activated. The vehicle had just exited a right curve and entered a straight section of roadway (**Figure 2**). The right front wheel departed the east side of the roadway and dropped off the pavement near a residential driveway. The ambulance traveled 11.5 m (37.7 ft) from the drop-off to impact with a guardrail on the north side of the driveway. It is unknown if the driver took any actions to avoid the crash.

Figure 2: Approach of the Ford to the crash site; arrow shows the area of impact with the guardrail

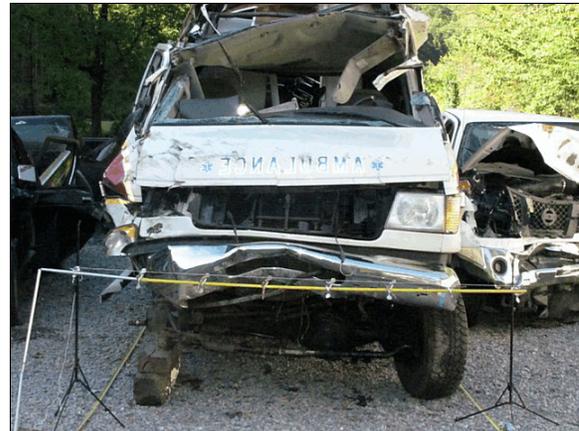
Figure 3: Damage on the front bumper of the ambulance from the impact with the guardrail

Exterior Damage Event 1: The ambulance sustained direct damage on the front bumper during the impact with the guardrail. The direct damage began at the front right bumper corner and extended 170 cm (66.9 in) across the front bumper. There was also overlapping damage on the right portion of the bumper from the rollover. The crush measurements were taken at the bumper level and the maximum residual crush was 22 cm (8.7 in) occurring at C₄. The table below presents the front crush profile.

Damage Classification Event 1: The Collision Deformation Classification (CDC) for the front plane damage was 12FDLW2. WinSMASH could not be used to calculate a Delta V since an impact with a yielding object is out of scope for the program and there was overlapping damage from the rollover on the bumper. The severity of damage on the bumper was moderate.

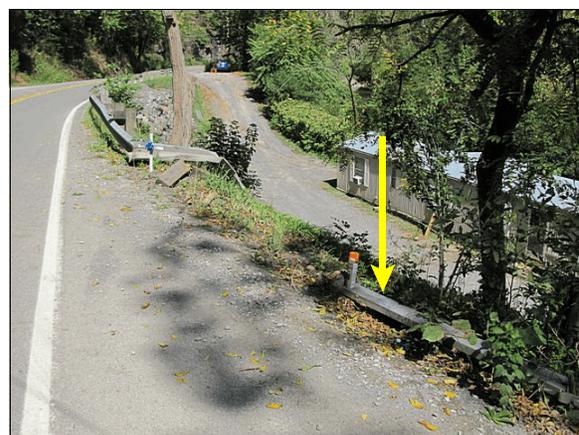
Crash: The front plane of the ambulance (**Figure 3**) impacted the guardrail (**Figure 4**, event 1). The impact broke three of the guard rail posts and bent the guardrail to an approximate 90 degree angle as the ambulance dropped off the embankment. The vertical drop from the roadway to the bottom of the embankment was approximately 6.1 m (20 ft). The ambulance rolled over (event 2) right side leading 3 quarter

Figure 4: Impact area with the guardrail, arrow shows the initial area of contact with the guardrail

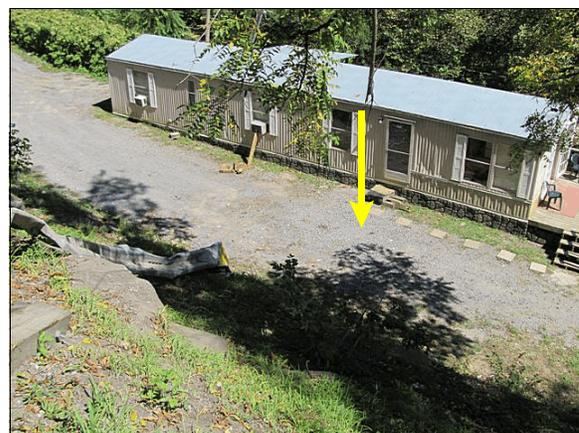
turns and came to final rest on the left side plane in a residential driveway heading north (**Figure 5**). During the rollover, the unrestrained driver was partially ejected through the partially open left front glazing. The driver's head was entrapped between the left roof side rail and the ground, and he sustained a fatal injury. The unrestrained EMT was displaced off the bench seat during the rollover and came to final rest between the patient cot and the left side of the patient compartment. The patient cot remained secured by the antler bracket and rail clamp. The patient remained secured on the cot by the three restraints. The passenger remained restrained on the bench seat.

Figure 5: Arrow shows the area of final rest of the ambulance

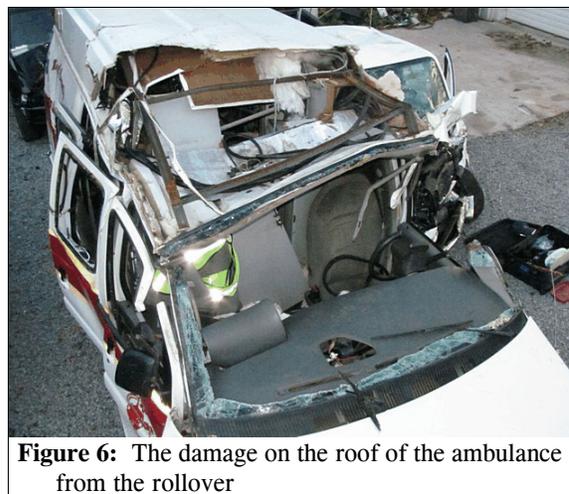
Figure 6: The damage on the roof of the ambulance from the rollover

Exterior Damage Event 2: The ambulance sustained damage on both side planes and the top plane during the rollover. The direct damage on the right side plane began 135 cm (53 in) rear of the right rear axle and extended forward 519 cm (200.4 in) to the end of the damaged right fender. The direct damage was intermittent along the side and resided primarily rear of the patient compartment entry doors. The direct damage on the left side plane began 146 cm (57.5 in) rear of the left rear axle and extended forward 549 cm (216.4 in). The direct damage on the top plane extended from the front of the hood to immediately rear of the B-pillars and involved the full width of the roof. The front portion of the fiberglass roof structure was broken and the metal frame was crushed. The maximum vertical crush on the roof was 72 cm (28.3 in), which included the crush of the fiberglass roof structure and its metal frame (**Figure 6**). The location of the maximum vertical crush was 15 cm (5.9 in) inboard and 12 cm (4.7 in) forward of the right B-pillar. There was no lateral crush of the roof structure.

Damage Classification Event 2: The CDC for the rollover damage was 00TYDO4. The WinSMASH program could not be used on this impact since a rollover is out of scope for the program. The severity of the damage was severe based on the extent of the crush on the roof.

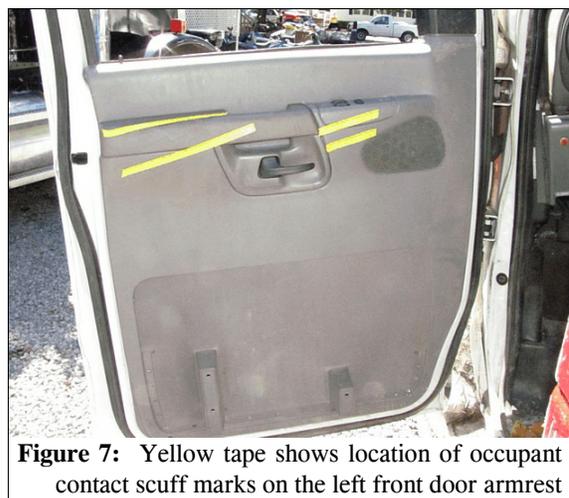
Vehicle Interior, Front Row: The inspection of the front row revealed two scuff marks on the left front door armrest (**Figure 7**) from contact by the driver’s left torso. Blood transfer was also located on the driver’s sunvisor and windshield header adjacent to the sunvisor. The steering wheel had been cut by rescue. There was no compression of the energy absorbing steering column.

Figure 7: Yellow tape shows location of occupant contact scuff marks on the left front door armrest

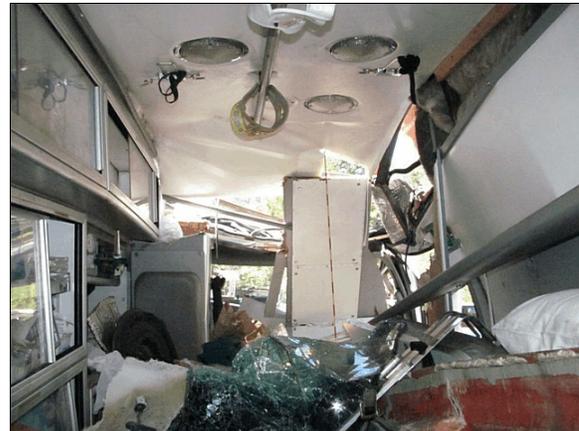
The patient compartment (**Figure 8**) was configured with a storage cabinet on the left side. A work shelf with a storage cabinet beneath it was located at the front right of the patient compartment adjacent to the entry doors. The left side storage cabinet was equipped with plexiglass sliding doors and was stocked with medical supplies. The front portion of the cabinet was displaced downward approximately 4 cm (1.6 in). The sliding doors were undamaged. A fold-up patient cot was stored on the back left side and was secured by a nylon strap. The cot remained secured and was not damaged. An M-size oxygen cylinder was located within a cabinet

Figure 8: View of the patient compartment from the patient loading doors.

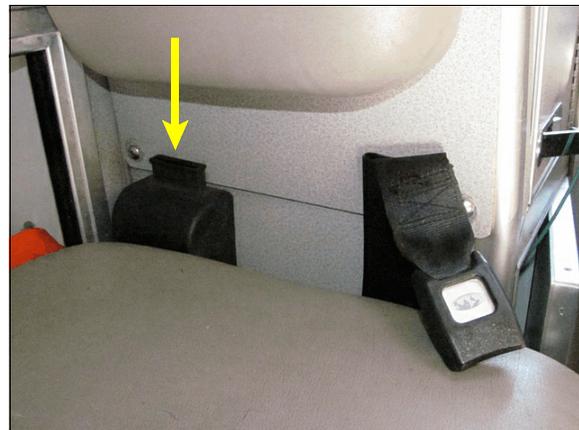
The paramedic seat was located on the forward left side of the patient compartment immediately behind the driver's seat. It was a non-adjustable box-mounted rear-facing seat and was equipped with a lap safety belt. The buckle portion of the safety belt was present but no latch plate/belt webbing was available (**Figure 9**).

Figure 9: The lap belt assembly for the rear-facing paramedic seat; no latch plate/belt webbing was available

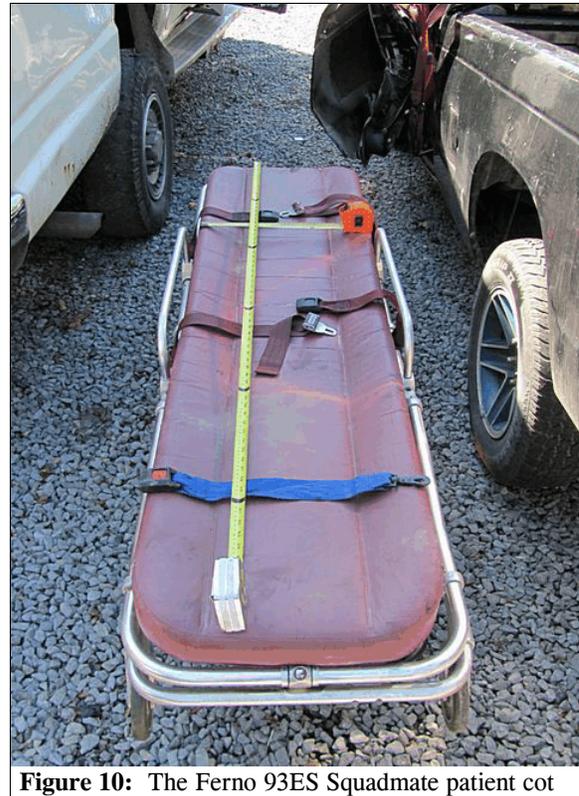
Patient Cot: The cot that was used to transport the patient was a Ferno 93ES Squadmate (**Figure 10**). There was no date of manufacturer located on the cot. The cot was constructed of steel tubing and the load capacity was indicated as 227 kg (500 lb). The cot was 204 cm (80 in) in length and 54 cm (21.3 in) in width. The mattress was 180 cm (70.9 in) in length, 47 cm (18.5 in) in width, and 11 cm (4.3 in) thick. The cot was undamaged. It was configured with three restraints. The restraints consisted of a non-adjustable buckle portion and an adjustable length locking latch plate portion. The restraints were tied to the cushion support frame with the exception of the buckle portion of the leg restraint, which was not secured to the cot at the time of the inspection. The latch plate portion of the leg restraint was equipped with a securement clip, which was broken. Inspection of the belts revealed historical usage evidence. On the upper torso

Figure 10: The Ferno 93ES Squadmate patient cot
